Restoration of ancient bronze bells. Part I: powder metallurgy

Ernesto Ponce L.¹ José de la Vega¹

ABSTRACT

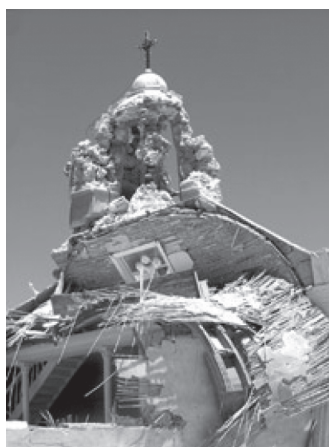
In cases of fall by an earthquake, as in Figure 1, bells tend to fall to the tower floor, which is generally made of stone. Bells tend to deform and their slope usually becomes damaged by the impact, as in Figure 2. The beauty of some of bells justifies restoration, as in Figure 3.

Figure 1. Bell tower in Northern Chile collapsed by an earthquake in 2005.

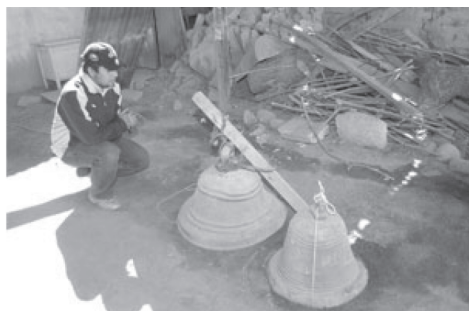
Figure 2. Bells collapsed by an earthquake in 2005.

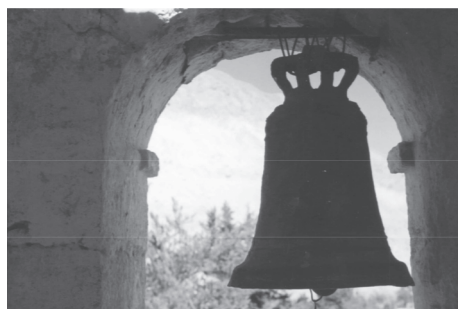
Figure 3. Bell found in Northern Chile.

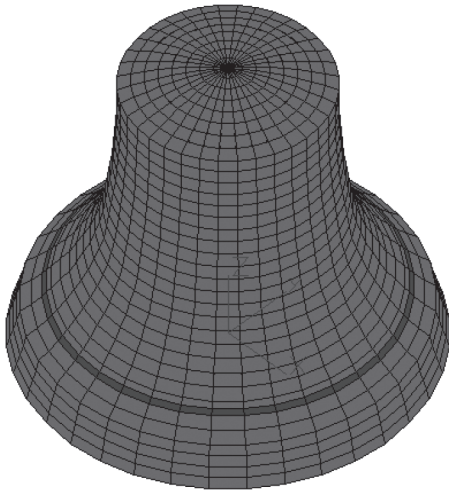
A model of stress in an elastic medium, computed with ALGOR (now Autodesk) finite element software package, which includes a Cu-Sn repair ring, is shown in Figures 4, 5, and 6. Input data represent density and modulus of elasticity of the materials involved. The clapper is simulated striking from the inside of the piece with a force of 408 N. Usual impact forces tend to be lower than that measure. Predictions are Von Mises stresses in N/m². Conditions at the edge were calculated considering free rotation in the dome central nodes in the same direction as the strike, simulating the piece hanging from the upper base. The geometry of the bell was taken from the actual model. The model used 2160 3D elements brick type, 8 nodes per element. The filled crack used 120 small elements (for greater precision). Three meshes were tested, leaving us with the most accurate.

Figure 4. Bell model with a Cu-Sn repair ring.

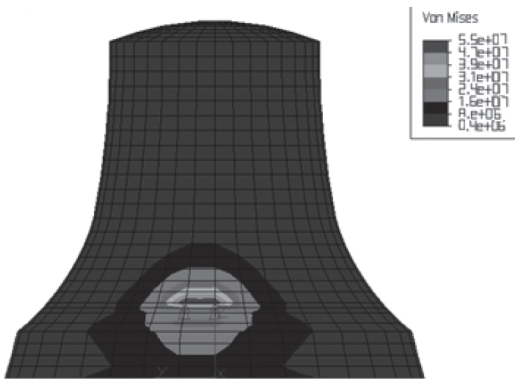
Figure 5. Lateral view showing external stresses of the bell when receiving the clapper strike with a force of 408N. Stresses are in N/m².

Finite elements predicted a stress of 0.055 GN/m^2 for a clapper impact of 408 N. This stress is lower than the rupture stress in traction of commercial cast bronze (0.37 GN/m^2).

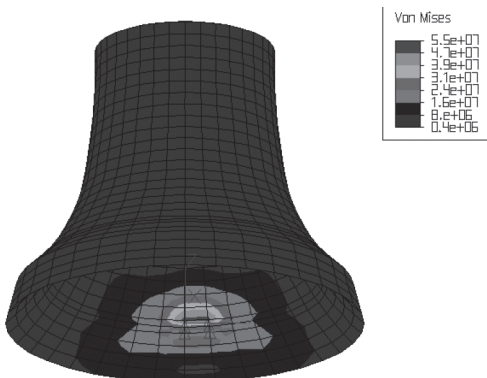
Figure 6. Interior view of the bell indicating the stress map when receiving the 408 N clapper strike. Stresses are in N/m².

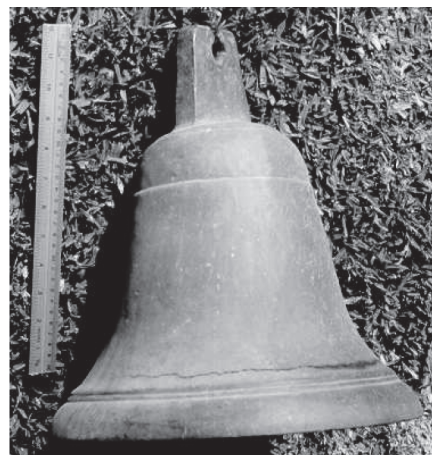
A fissured church bell from the late 19th century was restored, which is in no use due to a crack transverse to the axis. The fissure extends along the slope of the bell in most of the circular perimeter of the clapper strike. Given the nature of the fissures and the aesthetic complications of electrical or oxyethylene

Figure 7 shows the crack that surrounds the slope of the bell, and that is found behind the area of clapper striking, forming a line around the perimeter.

Figure 7. Fissured church bell.

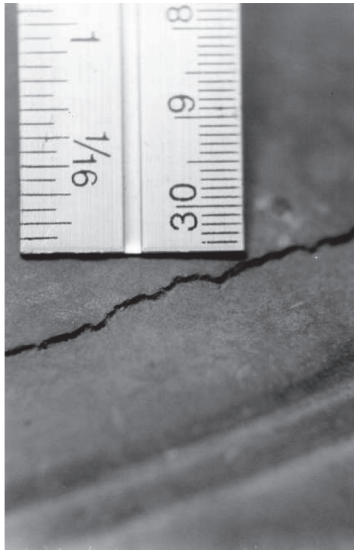
Figure 8 is an amplification of the external area of the bell, the crack having a dimension of around 1 mm.

Figure 8. External side of a transverse crack.

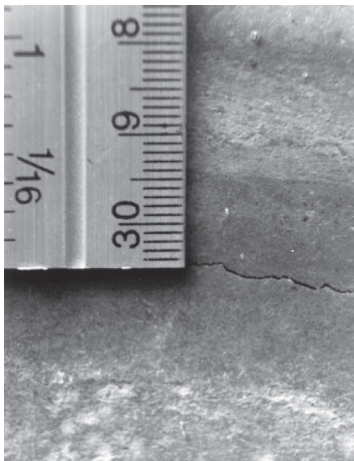
Figure 9 shows the internal side, the area of the clapper strike, where the crack measures less than 1 mm.

Figure 9. Internal side of a through-wall crack. The wear caused by the clapper can be observed.

In this damaged piece, as well as in many others found in Northern Chile, the clapper was made of wrought iron, not of Cu, bronze or grey cast iron. The useful lifetime of the bell was reduced due to higher hardness and lower relative deformation of the impact material.

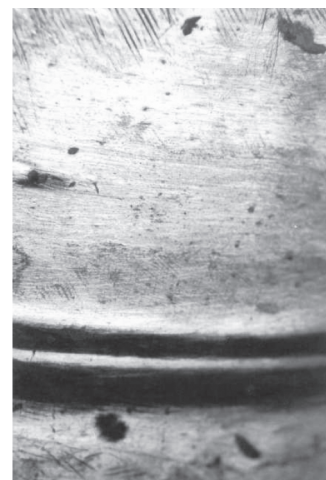
Figure 10. Restoration with molten powder Cu and Sn. The remainings of external welding have not been polished yet.

Figure 10 shows repair of the crack with powder metallurgy welding; no polishing. ASTM 100-mesh Cu powder and powder Sn were used. The crack was previously cleaned with acid and then tin-plated, the two sides of the crack being separated from each other. The crack was filled with the powder mix to be then fused with a butane torch. Figure 11 shows the image of the piece polished and amplified; a thin scar signals restoration.

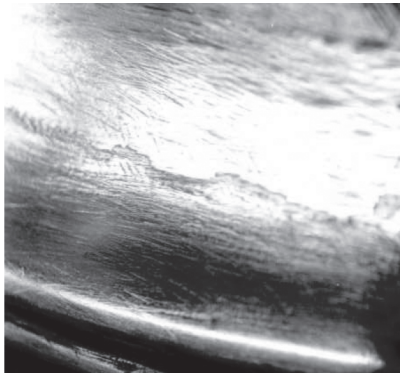
Figure 11. Amplified crack repair. The surface has been polished.

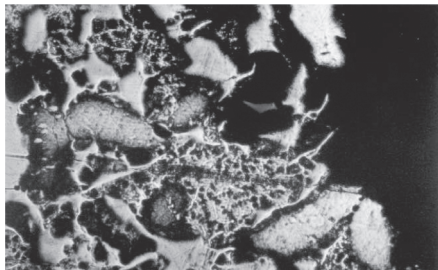
Figure 12. 100-mesh powder Cu and Sn mix. Incorrect joint is shown in big cavities (dark-colored right side). 50X amplification. Untinned crack contours. The edges of the crack were not tin-plated.

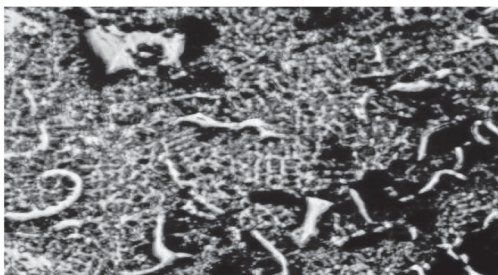
Figure 13. 100-mesh Brass and powder Sn, and Sn welding. The big number of dark-colored impurities creates a bad joint. 50X amplification.

Fusions tried with a powder combination of 75% powder brass and 25% powder Sn failed due to formation of impurities when welding. When trying to apply the butane torch flame, a significant amount of slag was formed, and this prevented a good joint.

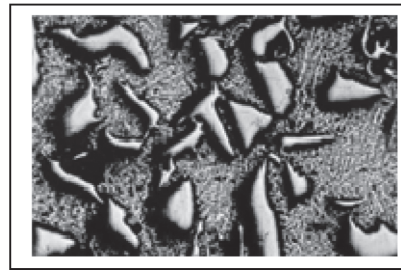
Figure 14. 60-mesh Cu and Sn, and Sn welding. 50X. Tin-plated crack. Good Cu anchors can be observed in the Sn matrix. 35-mesh and 100-mesh copper micrographs are similar, except from the size of Cu particles.

Micrographs of joints indicate the existence of material composed of a Sn matrix and Cu chips that creates an anchor in it. Brass is neither formed nor sintered powder metallurgy material.
